Enhanced Preliminary Assessment Report:

Coraopolis PI-71L Army Housing Units
Moon Township, Pennsylvania

October 1989

Environmental Research Division
Argonne National Laboratory
Argonne, Illinois 60439

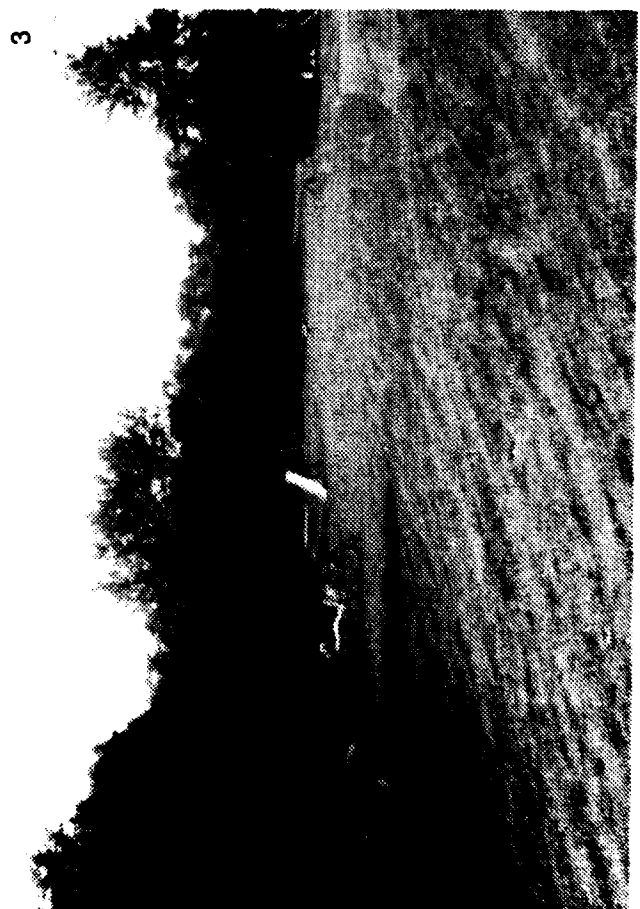
3

1. Front view of the housing units.
2. Rear of the units and open land behind housing area; at left center is the playground, shown at closer range in view #3 following.
3. Playground at the housing area.
4. Electrical transformer at the top of the utility pole; transformers at this site are owned by the local utility company.
5. Natural gas regulator.
6. The sewage-treatment system; sand pit and valve box shown here.
7. Sewage-treatment system, treatment tank; because of problems in the existing system, it is scheduled to be replaced by sewage services from the Moon Township system, but no date for the changeover is set.

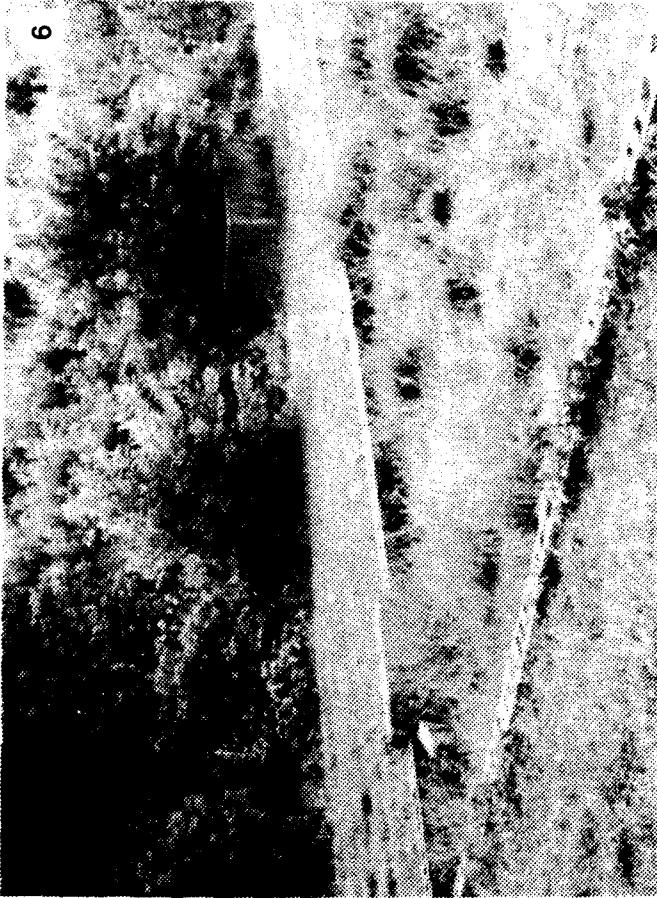
Currently, the sewage treatment facility is inoperative. However, sewage from the houses is still flowing by sewers to the treatment facility's septic tank where it is removed quarterly by a local contractor for off-site treatment. The current inoperative condition of the facility is reported to be the direct result of vandalism to above-ground equipment. The alternative mode of operation (periodic removal of sewage from the septic tank for off-site treatment) is not resulting in an adverse impact to the environment. There have been no reports of problems with the treatment facility prior to the vandalism incident.

The sewage treatment facility at this housing site is inoperative, although no environmental degradation results from the current method of sewage treatment. Current plans are to connect to the Moon Township sanitary system but no definite date for this connection has been set. An alternative option, repairing the system, is equally acceptable from an environmental standpoint. Permanent corrective action to the sewage problem should be implemented as soon as possible.
